1. AGENCY USE ONLY (Leave Blank)	2. REPORT DATE	3. REPORT TYPE AND DATES COVERED	
	March 1996	Final Technical Report 010992 - 290296	
4. TITLE AND SUBTITLE  Damage and Failure Behavior of SiC SCS-6/Timetal 21S Metal Matrix Composite			5. FUNDING NUMBERS  FQ8671-9201544 2302/BS  <i>92-C-0063</i>

6. AUTHOR(S)  D. A. Shockley, S. W. Kirkpatrick, C. G. Schmidt, and T. Kobayashi			
7. PERFORMING ORGANIZATION NAME(S) AND ADDRESS(ES)  SRI International 333 Ravenswood Avenue Menlo Park, CA 94025-3493		8. PERFORMING ORGANIZATION  AFOSR-TR-96  <i>0250</i>

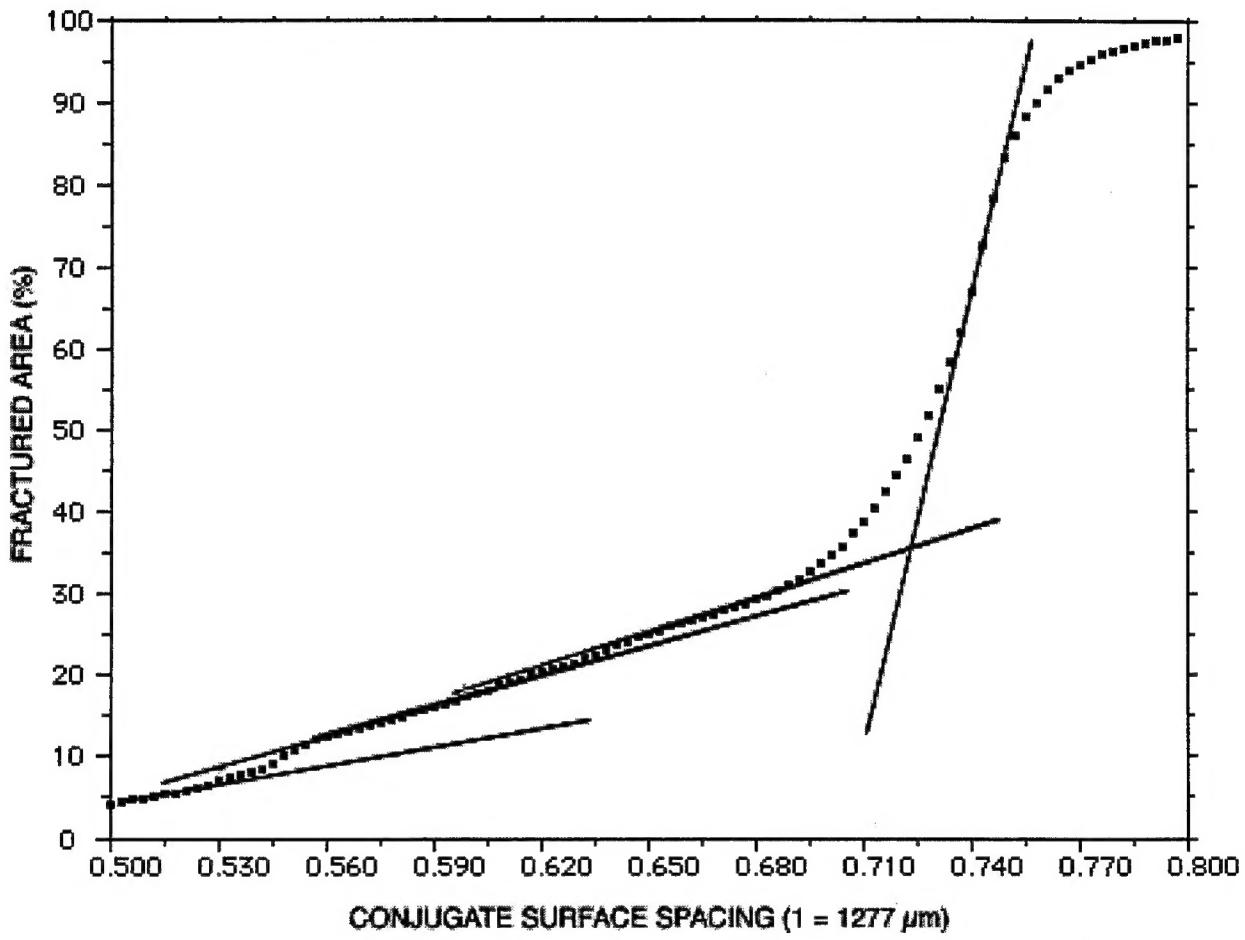
Figure A.6. Fractured area increase rate as a function of conjugate surface spacing.

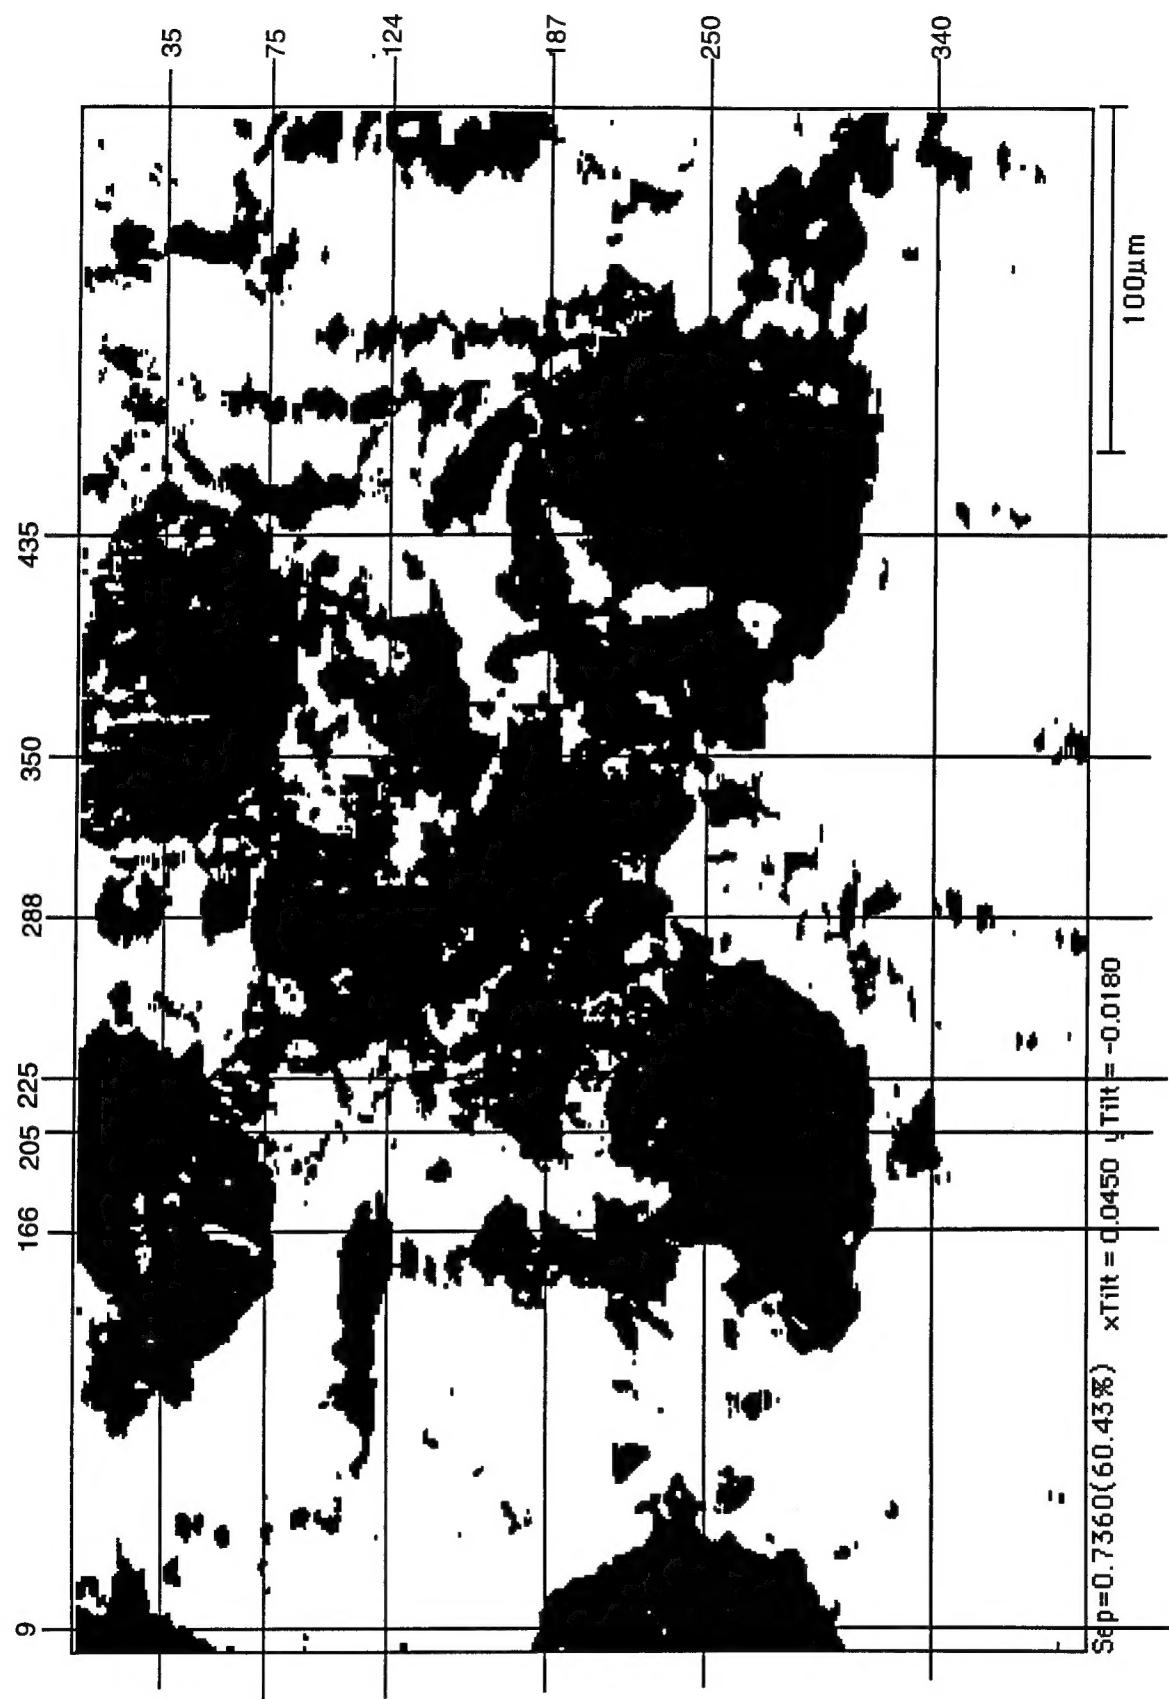
Figure A.7. Fractured area projection plot showing the locations at which cross-sectional plots were made.

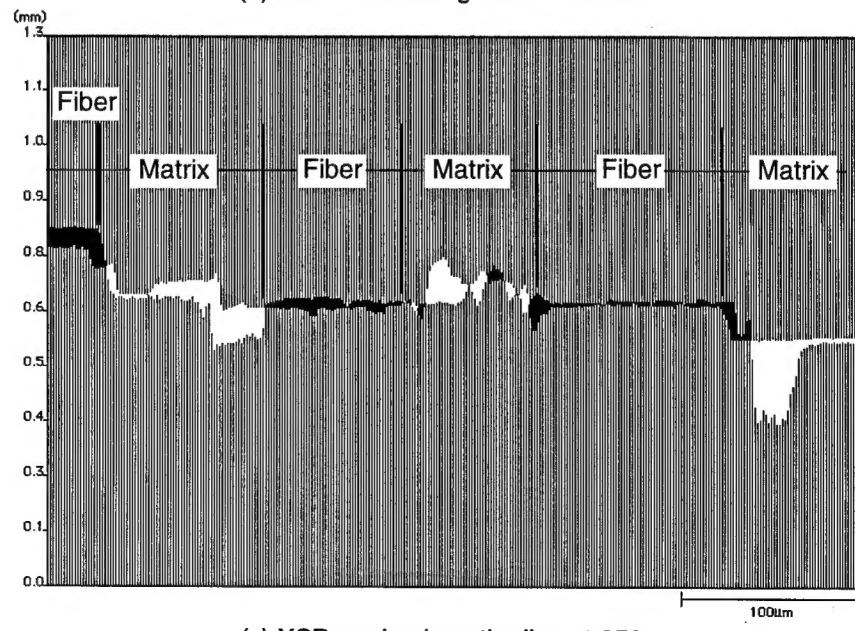
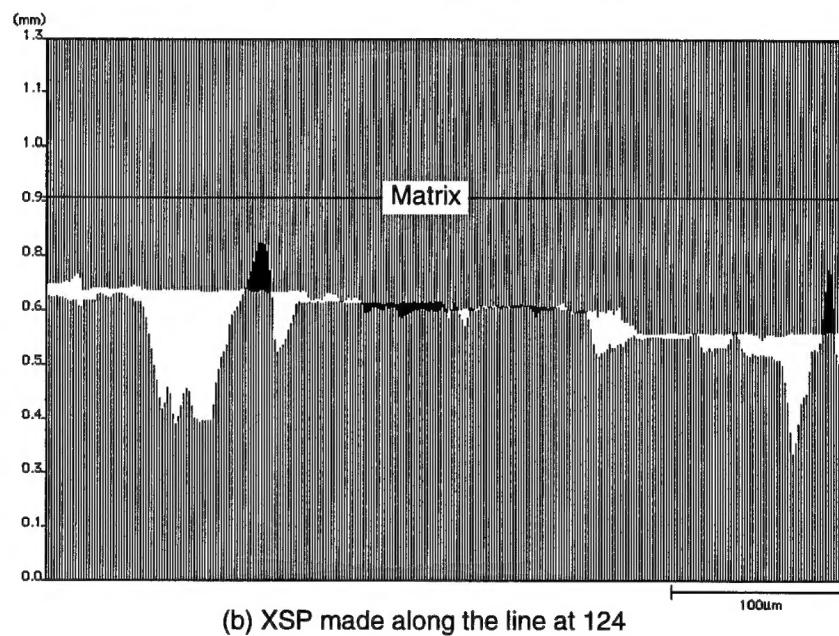
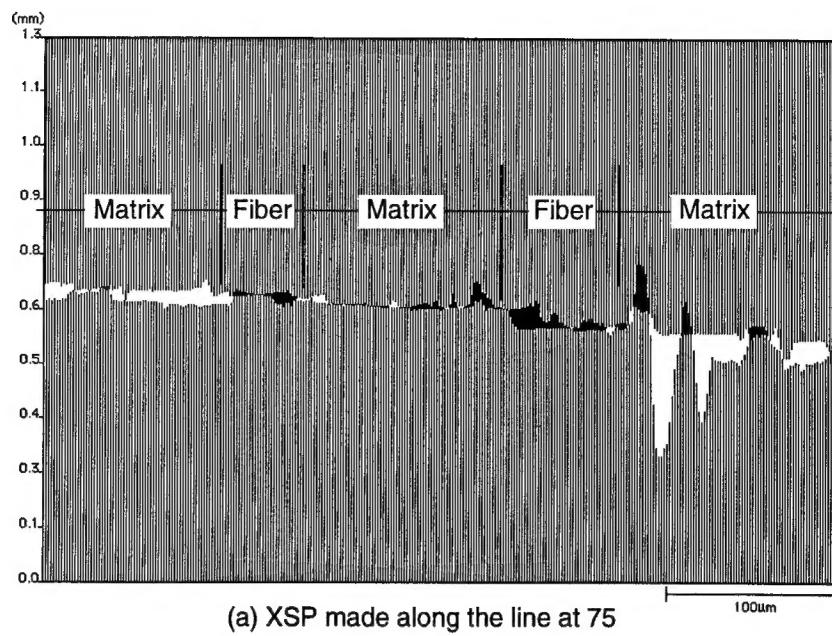
Figure A.8. Cross-sectional plots made parallel to horizontal direction.
